Debris/Ice/TPS Assessment And Photographic Analysis For Shuttle Mission STS-39

Gregory N. Katnik
NASA/Kennedy Space Center

DEBRIS/ICE/TPS ASSESSMENT
AND
PHOTOGRAPHIC ANALYSIS
OF
SHUTTLE MISSION STS-39

April 28, 1991

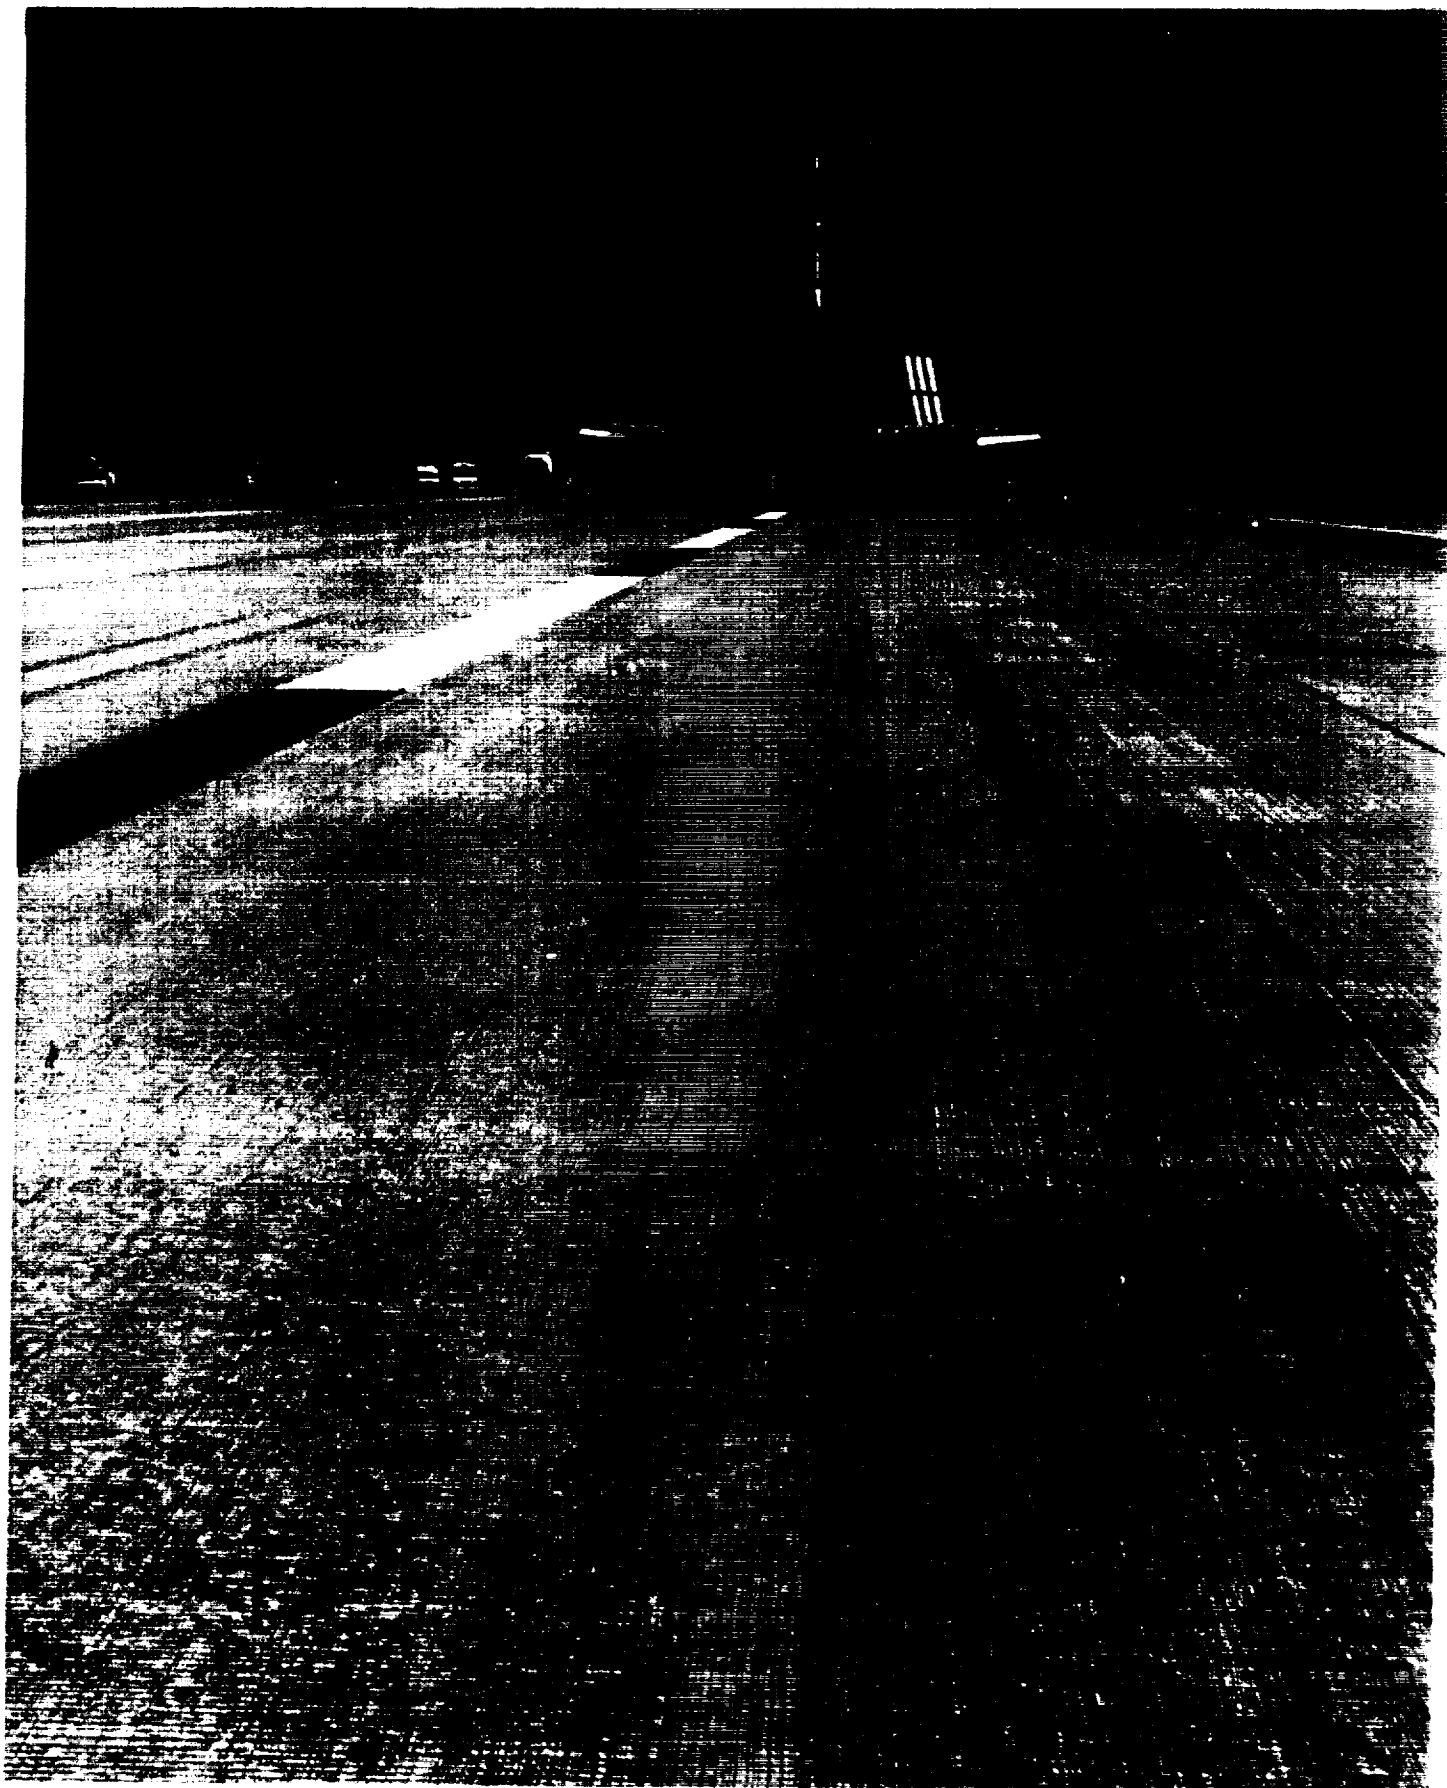
Material from the RH main landing gear tires lay on the runway within 1000 feet of the Orbiter stop point. There was no tire material at the touchdown point.
